Mobile Home Bedroom Fire Studies: The Role of Interior Finish

Interim Report

NBSIR 78-1531

MOBILE HOME BEDROOM FIRE STUDIES: THE ROLE OF INTERIOR FINISH

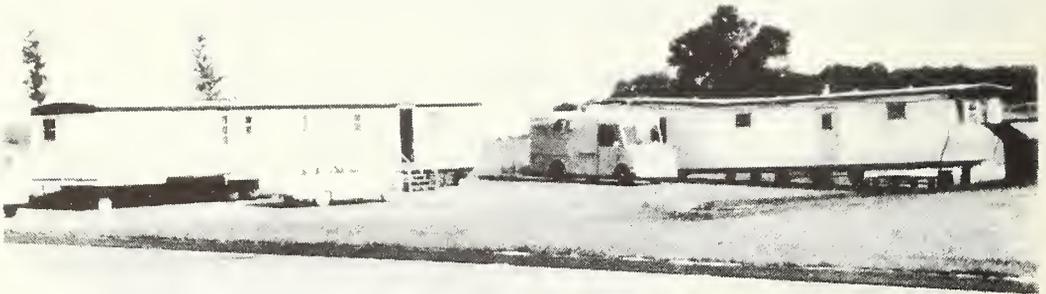
Figure 1. Photographs of Typical Single-Wide Mobile Homes Used in Conducting Full-Scale Fire Tests

The test facility was a conventional three bedroom single-wide mobile home approximately 3.7 x 18.3 m (12 x 60 ft) with the master bedroom (bedroom #1)⁵ being selected as the room of fire origin (figures 1 and 2). The bedroom was approximately 3.5 m (11 ft 4 in) wide, and 2.8 m (9 ft 2 in) long, resulting in a floor area of 9.8 m² (105 ft²), and had a ceiling height of 2.1 m (7 ft). The single opening into the bedroom was through a doorway 0.76 m (30 in) wide and 2.0 m (6 ft 8 in) high, connecting the bedroom with the corridor. The initial item to be burned was positioned in the southeast corner of the bedroom; figure 3 shows the location of the upholstered chair and the bed in the bedroom.

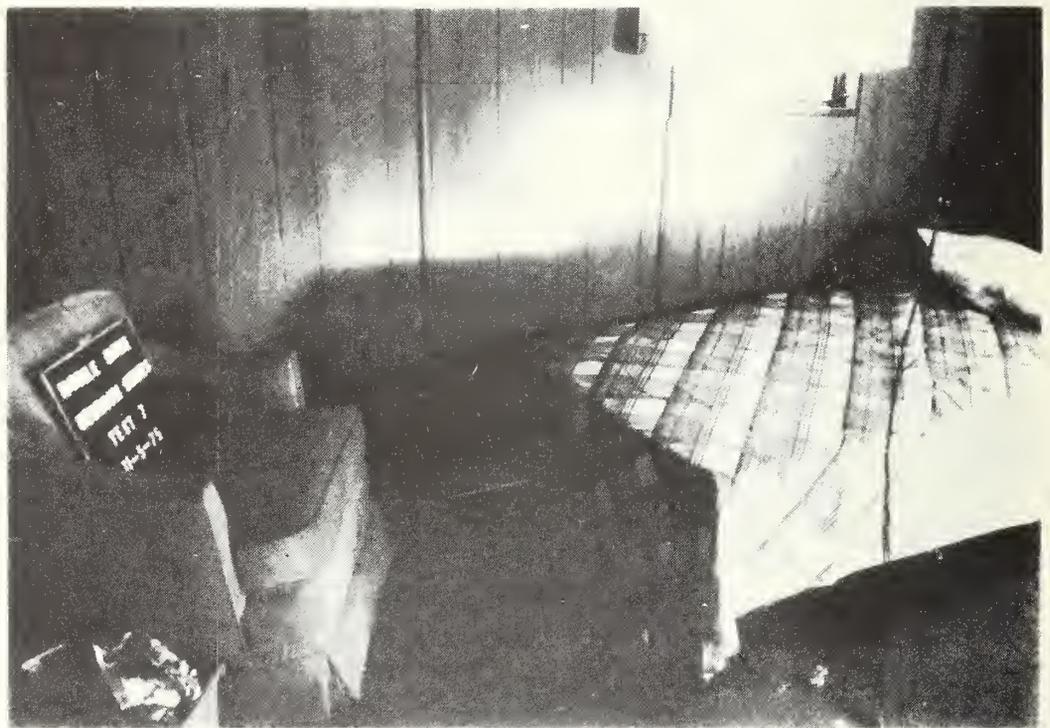
Figure 3. Photographs Showing Upholstered Chair Positioned in Southeast Corner of Bedroom
